DEPARTMENT OF TRANSPORTATION

Contract #: 04-0120F4Cty: SF/ALA Rte: 80 PM: 13.2/13.9File #: 69.28**WELDING INSPECTION REPORT****Resident Engineer:**Pursell, Gary**Address:** 333 Burma Road**City:** Oakland, CA 94607**Report No:** WIR-011982**Date Inspected:** 12-Feb-2010**Project Name:** SAS Superstructure**OSM Arrival Time:** 700**Prime Contractor:** American Bridge/Fluor Enterprises, a JV**OSM Departure Time:** 1900**Contractor:** Zhenhua Port Machinery Company, Ltd (ZPMC), Changxing Island **Location:** Shanghai, China**CWI Name:** Li Yang**CWI Present:** Yes No**Inspected CWI report:** Yes No N/A**Rod Oven in Use:** Yes No N/A**Electrode to specification:** Yes No N/A**Weld Procedures Followed:** Yes No N/A**Qualified Welders:** Yes No N/A**Verified Joint Fit-up:** Yes No N/A**Approved Drawings:** Yes No N/A**Approved WPS:** Yes No N/A**Delayed / Cancelled:** Yes No N/A**Bridge No:** 34-0006**Component:** OBG Segment**Summary of Items Observed:**

OBG # TRIAL ASSEMBLY YARD (6BE)

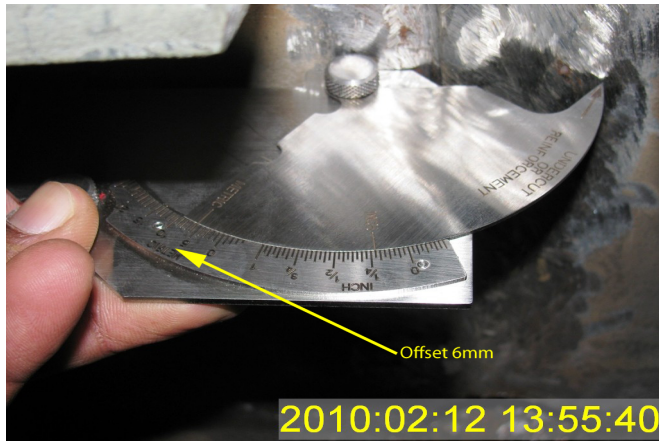
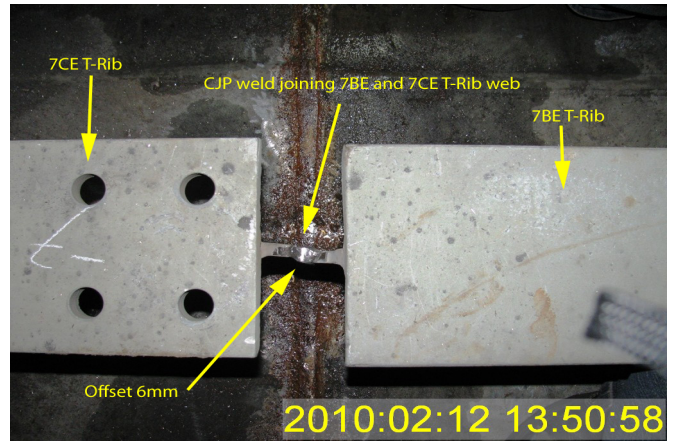
During the Quality Assurance (QA) random in-process visual inspection of T-Ribs in the OBG Trial Assembly area, this QA inspector discovered the following issues:

-Multiple T-Rib web welds between the 7BE to 7CE (transverse splice) were misaligned across the weld joints as listed below.

-The welds are Complete Joint Penetration (CJP) butt welds.

-The maximum out of tolerance offset measurements across the weld per AWS D1.5 2002 is 3mm.

Weld number	T-Rib numbering from work point E4 (CB side) to E3 (BK side)	Offset
BP171-001-020	1st T-Rib	4
BP171-001-022	2nd T-Rib	7
BP171-001-024	3rd T-Rib	6
BP171-001-028	5th T-Rib	5
BP171-001-030	6th T-Rib	4
BP117-001-022	14th T-Rib	4
BP117-001-030	18th T-Rib	4

Weld number	T-Rib numbering from work point E3 (bottom) to E1 (top)	Offset
SP365-001-044	1st T-Rib	5
SP365-001-048	2nd T-Rib	4
SP365-001-052	3rd T-Rib	4
SP365-001-056	5th T-Rib	5
SP311-001-063	13th T-Rib	6
SP311-001-061	14th T-Rib	5

SP311-001-059	15th T-Rib	6
SP311-001-057	16th T-Rib	5
